Development and Evaluation of Processes for Deposition of Ni/Co-Cr-AlY (MCrAlY) Coatings for Gas Turbine Components

**Solar Turbines International
P.O. Box 80966
San Diego, California 92138**

TECHNICAL REPORT AFML-TR-79-4097

Final Report for Period 1 November 1976 to 1 September 1978

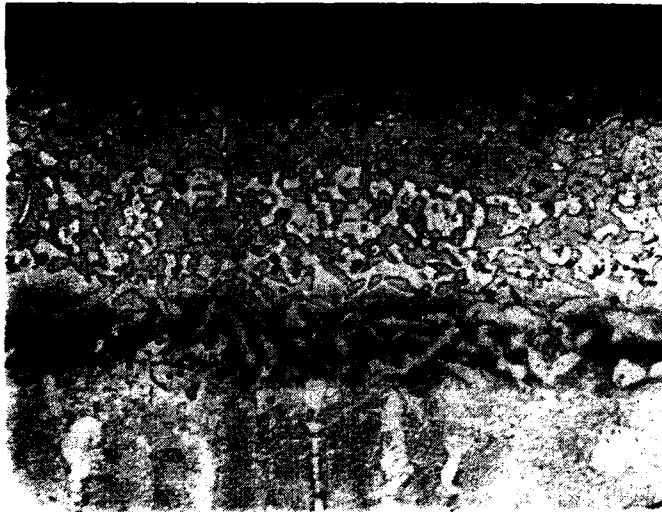
Specimen No. R50

Magnification: 250X

Figure 19. Microstructures of Rene' 125 Tensile Specimens With and Without 500 Hours Pre-oxidation at 899°C in Air

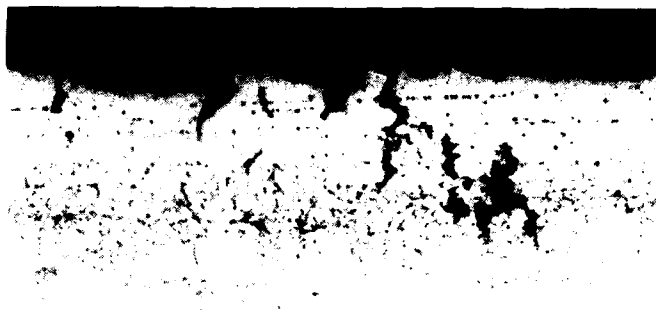
Specimen No. X40

Figure 21. Microstructures of X-40 Specimens After Tensile Testing With and Without 500-Hour Pre-oxidation at 987°C in Air

Figure 21 shows the microstructure of pre-oxidized and unexposed tensile specimens near the fracture surface. Note the formation of a discrete secondary phase in the coating matrix of the pre-oxidized specimen as beta NiAl deteriorated to gamma and gamma prime. Furthermore, interdiffusion across the interface resulted in merging the coating layer with the substrate.

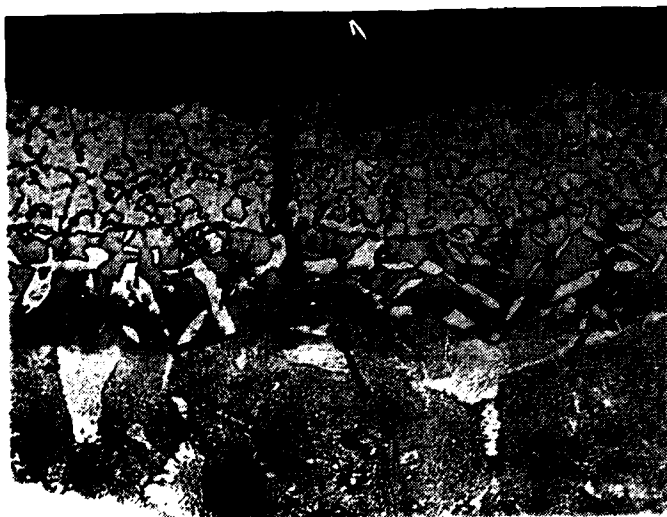
Figure 23.

Failed Strain Tolerance
Specimens With Single-
Cycle CCRS CoNiCrAlY Coating
on Rene' 125

Specimen No. R77

Magnification: 250X

Figures 23 and 24 show the microstructure of two CCRS coatings. Note that the single-cycle coating appears to be multi-phased throughout while the two-cycle coating has a single-phase beta layer near the coating surface. The additional second heat cycle in the latter may have caused further diffusion of aluminum into the coating, resulting in a more brittle matrix phase at the surface.

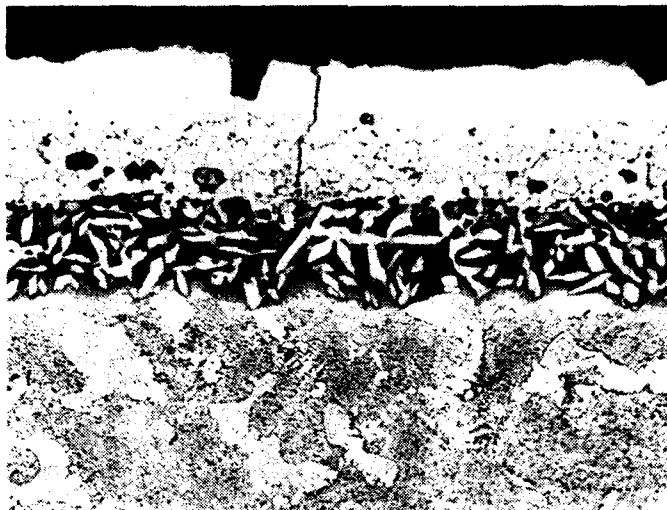
Figure 24.

Failed Strain Tolerance
Specimen With Two-Cycle
CCRS CoNiCrAlY Coating on
Rene' 125

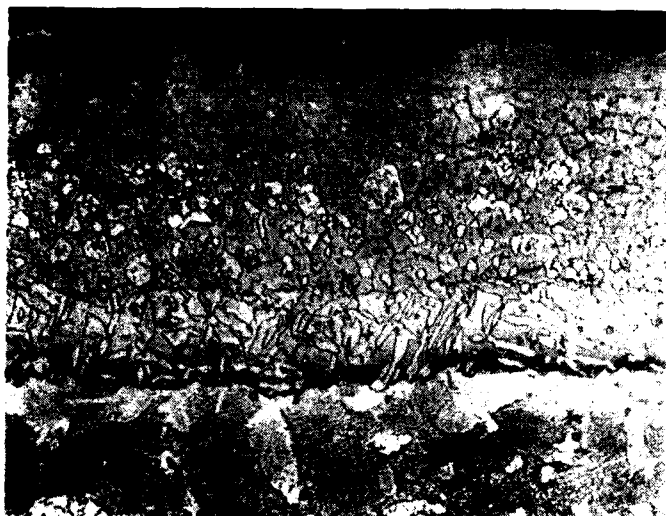
Specimen No. R11

Figure 25. Microstructure of CCRS CoNiCrAlY Coated Rene' 125 Fatigue Specimen After 3.29×10^4 Cycles at 20 Cycles/Minute (R = 0.2) at 760°C

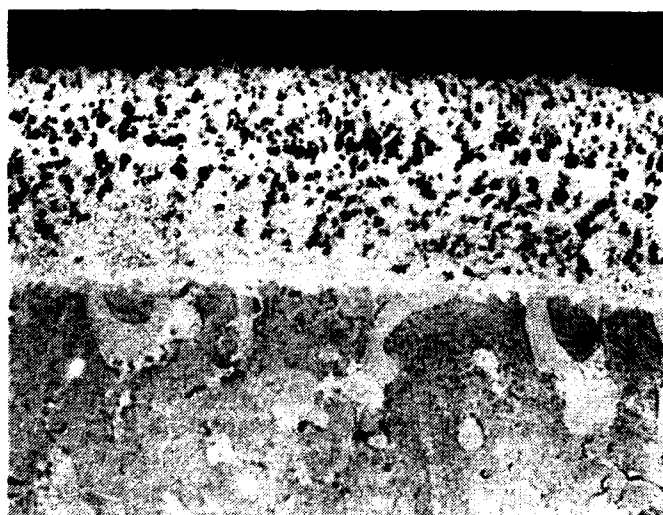
B. Specimen No. S14

Cooler Zone

Figure 35. Microstructures of BC32 (PVD NiCrAlY) Coated Rene' 125 Specimens After 239 Hours of Hot Corrosion Rig Testing

Figure 34 shows the microstructure of PVD CoCrAlY after 174 hours of testing. Coating continuity was good with no cracking or spallation. However, the coating itself showed internal oxidation and porosity. The PVD NiCrAlY coating exhibited poor corrosion resistance. Figures 35 and 36 show microstructures of PVD NiCrAlY coated Rene' 125. In the hot zone the coating was initially 100 percent penetrated with widespread voiding and internal oxide formation. Note that in Figure 36B corrosion attack was concentrated in the leaders which are the weakest structural feature in PVD coatings. These leaders provide a direct path for gaseous corrosidents to the interface and substrate.

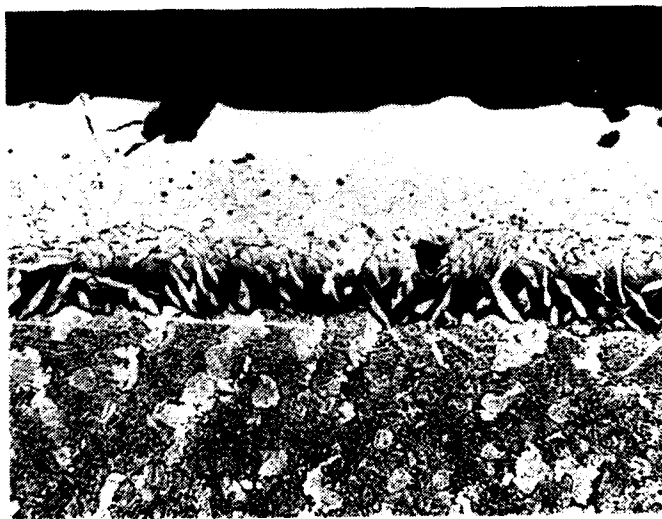
B. Specimen No. S19

Cooler Zone

Figure 37. Microstructures of CCRS Lot 8864 Coated Rene' 125 Specimens After 239 Hours of Hot Corrosion Rig Testing

CCRS CoNiCrAlY coating applied to Rene' 125 performed best in hot corrosion testing. Typical microstructures are shown in Figure 37. Kirkendall voids are noted in the coating as aluminum is depleted and beta-NiAl is converted to low aluminum phases (gamma solid solution). Specimen No. S4 was found to be locally degraded, as shown in Figure 38, with a maximum penetration of approximately 50 percent.

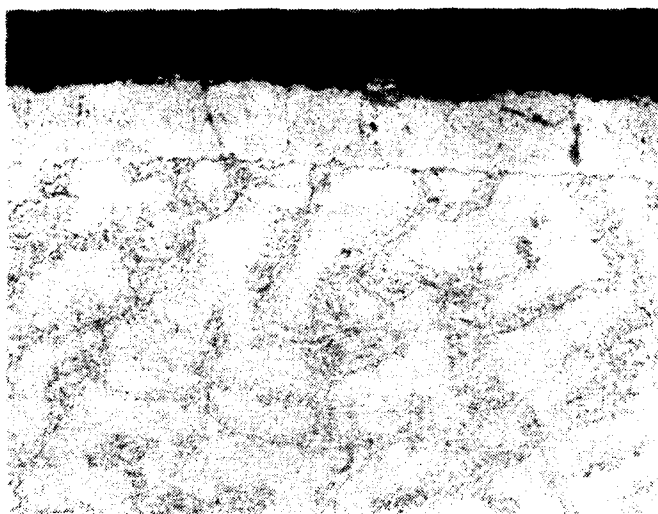
B. Specimen No. Y1

Cooler Zone

Figure 42. Microstructures of PVD NiCrAlY Coated X-40 Specimen
After 174 Hours of 871°C Hot Corrosion Burner Rig
Testing

PVD NiCrAlY coated X-40 performed extremely poorly in hot corrosion testing. After 174 hours, the coatings were essentially 100 percent penetrated with corrosion attack initiating at the interface and even in the substrate alloy. This is shown in Figure 42 where 75 percent of the coating was eroded away by the gas stream, and a continuous band of interfacial oxidation can be observed. Total penetration of the coating in certain spots had resulted in intergranular attack of the X-40 parent material. In the cooler regions, leaders characteristic of PVD applications were noted together with severe cracks, both of which provide direct pathways for corrodents to attack the interface.

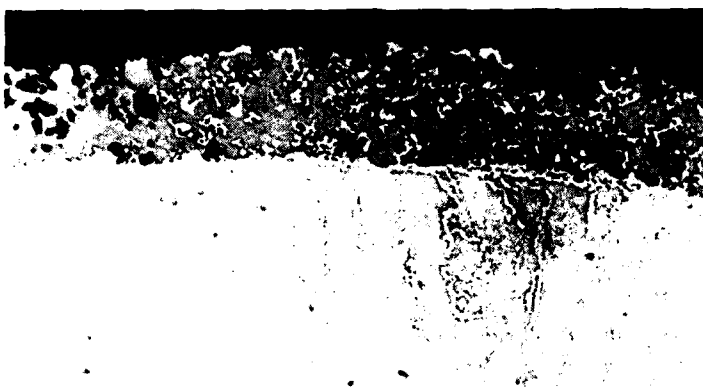
B. CCRS CoNiCrAlY

C. CODEP B

Figure 45. Photomicrographs of Coated X-40 Specimens After 478 Hours at 1700°F, 5 ppm Hot Corrosion; Note Even Though One CCRS Coating is Not Fully Dense, it Has Excellent Corrosion Resistance.

GE reported that CCRS CoNiCrAlY, PVD CoCrAlY and CODEP B coating systems provided protection after 478 hours of testing (Fig. 45). However, the CODEP B system was 50 percent consumed as a result of Na_2SO_4 induced frontal sulfidation. GE's results agree with STI's findings that, in spite of the less dense microstructures, the CCRS CoNiCrAlY on X-40 demonstrated excellent sulfidation resistance.

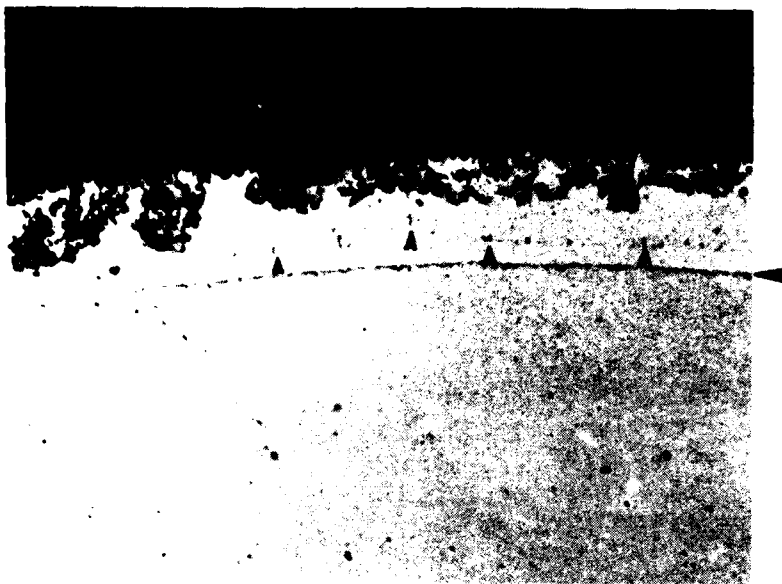
A. PVD NiCrAl

Figure 46. Photomicrographs of Coated MA754 Specimen, Tested for 236 Hours at 1700°F, 5 ppm; Arrows Indicate Chromium Sulfides Formed with a PVD Coating

Coated MA754 was evaluated at GE with CCRS CoNiCrAlY and PVD NiCrAlY for hot corrosion surface protection. Results showed that the CCRS coating was superior to the PVD NiCrAlY system. The tip of PVD NiCrAlY coated specimens was totally spalled, while the CCRS system showed minimal surface distress. Figure 46 shows the partially depleted (most gamma solid solution) NiCrAlY coating with chromium sulfides formed after 236 hours. On the other hand,
